**Flood Control Project Maintenance
Levee Inspections**

Maintenance Issue Types Only, Levee Inspection Report By Mile - Fall 2018

Reclamation District No. 1500 Sutter Basin

Waterway	Bank	Unit Miles	Inspection Start/End	Inspector
Unit No. 01 Sacramento River	Left	33.15	10/16/2018 10/18/2018	Zach Jojola

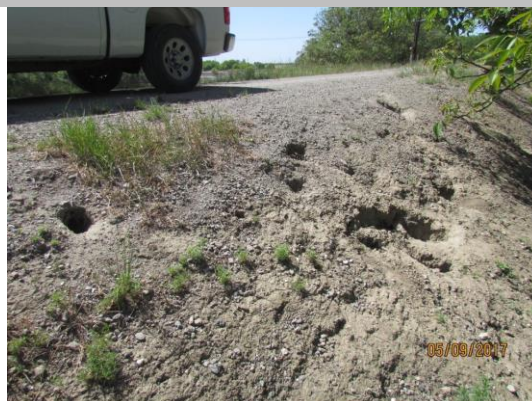
Photo 1 of 1 : FA_2018_RD1500_189_152_20180904_00074.jpg

View of rodent holes on landside slope. Spring 2017.

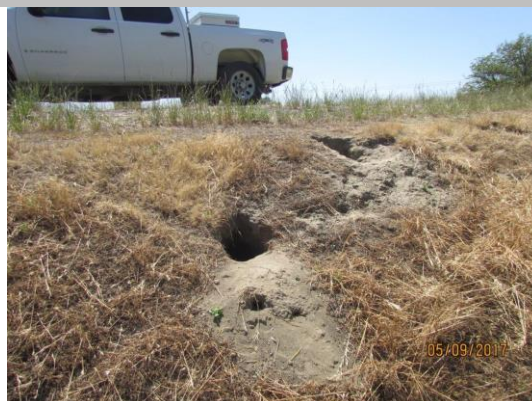
Photo 1 of 1 : FA_2018_RD1500_189_149_20180904_00072.jpg

View of rodent holes on landside slope. Spring 2017.

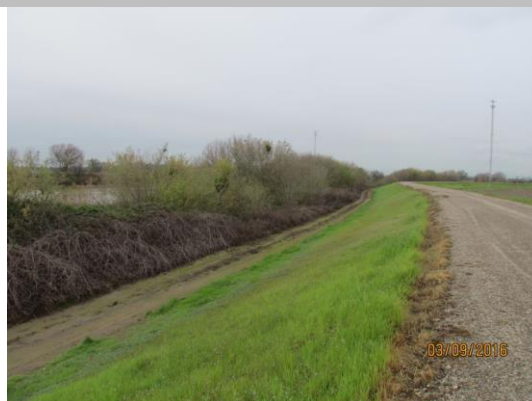
Photo 1 of 2 : FA_2018_RD1500_189_72_20180904_00028.jpg

LM Start	0.56	Rating **	A/W	Issue No.	72
LM End	0.82	Issue Type +	Ma	Location *	WS
Category	Earthen Levee			GPS Latitude/Longitude	
				Start	End
Item	Vegetation			38.764462°	38.764638°
				-121.683167°	-121.687690°
DWR ID	DWR_RD1500_01_s_2018_72				
Comment Code					
V8 : Environmental Requirements.					
Inspector Comment

View of the revegetation site on the waterward side toe of the levee looking upstream. Spring 2016.

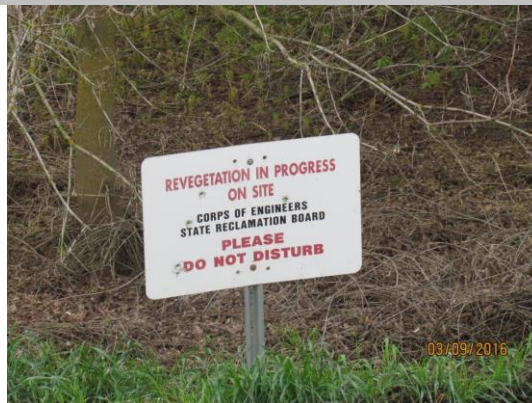
Photo 2 of 2 : FA_2018_RD1500_189_72_20180904_00029.jpg

Sign is located at the toe of the levee on the waterward side. Spring 2016.

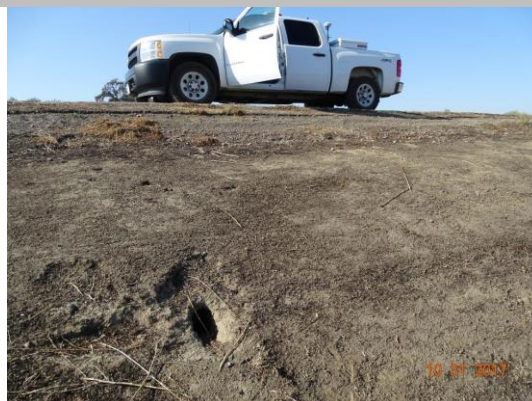
Photo 1 of 1 : FA_2018_RD1500_189_100_20180904_00041.jpg

View of hole on landside hope. Fall 2017.

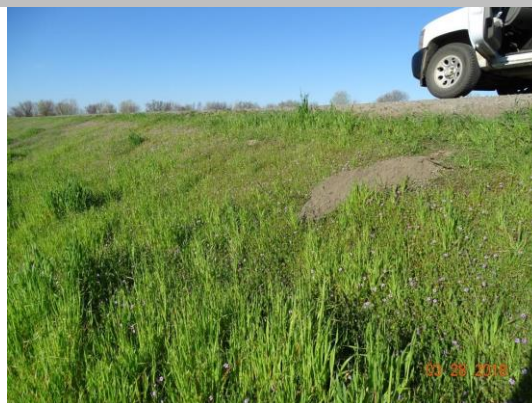
Photo 1 of 2 : FA_2018_RD1500_189_99_20180904_00039.jpg

LM Start	1.25	Rating **	M	Issue No.	99
LM End	1.25	Issue Type +	Ma	Location *	LS
Category	Earthen Levee			GPS Latitude/Longitude	
				Start	End
Item	Animal Control			38.769274 °	38.769274 °
				-121.691700 °	-121.691700 °
DWR ID	DWR_RD1500_01_f _ 2017_99				
Comment Code					
A3 : No rodents visible, but rodent burrows visible; need to backfill and compact or grout burrows.					
Inspector Comment					
Multiple rodent holes and mounds on landside slope.

Updated view of rodent holes. Spring 2018

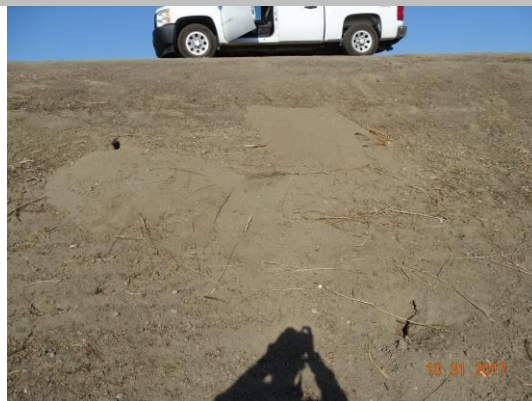
Photo 2 of 2 : FA_2018_RD1500_189_99_20180904_00040.jpg

View of holes and mounds on landside slope. Fall 2017.

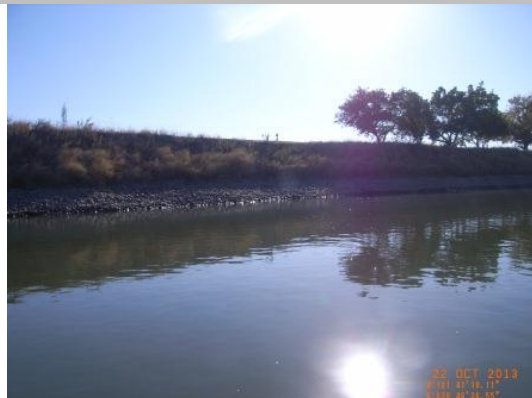
Photo 1 of 1 : FA_2018_RD1500_189_85_20181023_00063.jpg

2017 Site ID: SAC 86.3 L
Status: Eroding
2017 Field Notes: No observed change..
Site History: 2006 - New erosion upstream, new bank failures near levee but still fairly wide berm in most places. 2008 - Large berm, questionable as to if it should remain in the inventory. 2010 - Minor new erosion, old cobble starting to fail. 2011 - Cobble continues to unravel and additional slumping. 2012 - Minor new erosion at bank mid point. 2013 - Minor new erosion. 2016 - Toe relatively stable. Upper slope is over steepened.

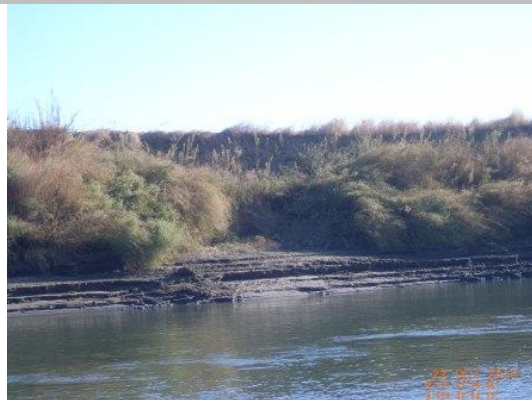
Photo 1 of 1 : FA_2018_RD1500_189_87_20181023_00238.jpg

LM Start	2.30	Rating **	A/W	Issue No.	87
LM End	2.52	Issue Type +	Ma	Location *	WS
Category	Supplemental			GPS Latitude/Longitude	
				Start	End
Item	2017 USACE Erosion Survey, DRAFT			38.781962 °	38.784936 °
				-121.688033 °	-121.690033 °
DWR ID	DWR_RD1500_01_f_2018_87				
Comment Code					
Inspector Comment					
2017 Site ID: SAC 87.1 L					
Status: Eroding					
2017 Field Notes: Large whole bank failure section in middle of site.					
Site History: 2010 - The upstream end of the repair site at 87.0. Repair					
did not extend far enough upstream. 2011 - New erosion pockets.					
2012 - Minor new erosion at toe. 2013 - Minor new erosion. 2015 -					
Significant new toe erosion. 2016 - Fresh erosion on riverbank.

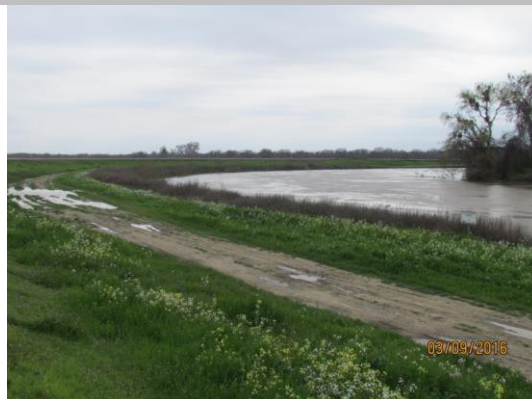
Photo 1 of 2 : FA_2018_RD1500_189_74_20180904_00030.jpg

View of the revegetation site along the edge of the berm on the waterward side of the levee looking downstream. Spring 2016.

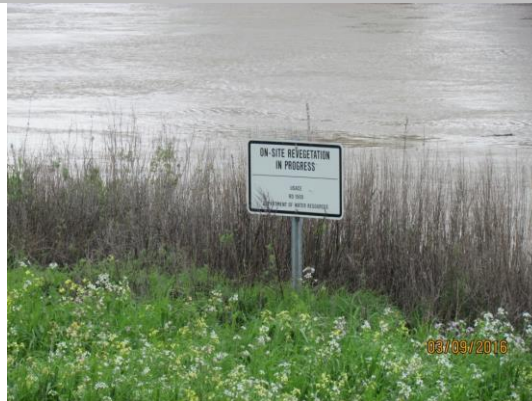
Photo 2 of 2 : FA_2018_RD1500_189_74_20180904_00031.jpg

Sign for the revegetation site by USACE.

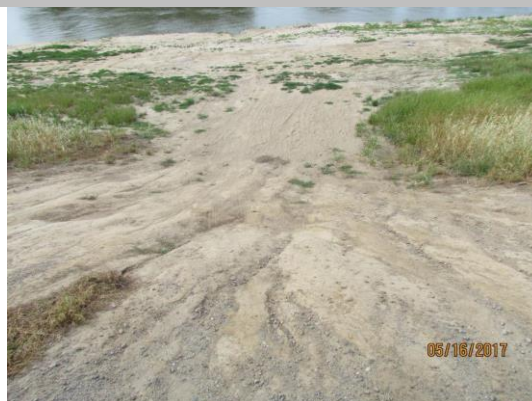
Photo 1 of 1 : FA_2018_RD1500_189_162_20180904_00076.jpg

LM Start	9.71	Rating **	A/W	Issue No.	162
LM End	9.71	Issue Type +	Ma	Location *	WS
Category	Earthen Levee			GPS Latitude/Longitude	
				Start	End
Item	Slope Stability			38.853564 °	38.853564 °
				-121.725379 °	-121.725379 °
DWR ID	DWR_RD1500_01_s_2017_162				
Comment Code					
S3 : Repair the levee slope damaged by vehicle traffic and prevent access where possible.					
Inspector Comment					
Area heavily accessed by trailer residents and fishermen. Recommend monitoring.

View of slope stability on waterside slope. Spring 2017.

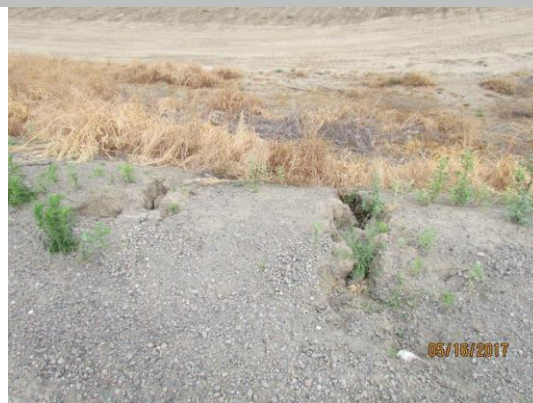
Photo 1 of 1 : FA_2018_RD1500_189_116_20180904_00052.jpg

LM Start	12.01	Rating **	M	Issue No.	116
LM End	12.01	Issue Type +	Ma	Location *	LS
Category	Earthen Levee			GPS Latitude/Longitude	
				Start	End
Item	Erosion / Bank Caving			38.870730 °	38.870730 °
				-121.752908 °	-121.752908 °
DWR ID	DWR_RD1500_01_s_2017_116				
Comment Code					
E2 : Schedule repair of erosion site prior to the next inspection.					
Inspector Comment					
Runoff erosion on landside levee slope.

View of erosion on landside slope. Spring 2017.

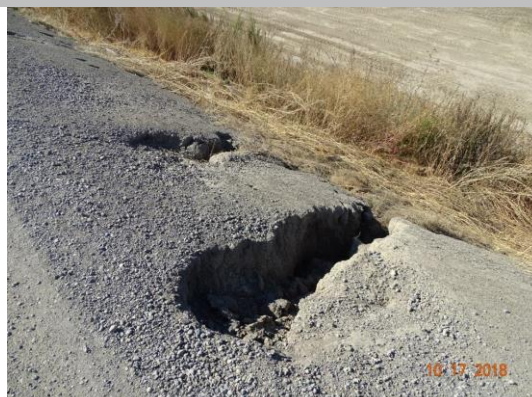
Photo 1 of 2 : FA_2018_RD1500_189_118_20181018_00233.jpg

Updated view of erosion on the landside slope. Fall 2018.

LM Start	12.57	Rating **	U	Issue No.	118
LM End	12.57	Issue Type +	Ma	Location *	WS
Category	Earthen Levee			GPS Latitude/Longitude	
				Start	End
Item	Erosion / Bank Caving			38.867108°	38.867108°
				-121.761498°	-121.761498°
DWR ID	DWR_RD1500_01_f_2015_118				
Comment Code					
E2 : Schedule repair of erosion site prior to the next inspection.					
Inspector Comment					
Recommend backfilling erosion.

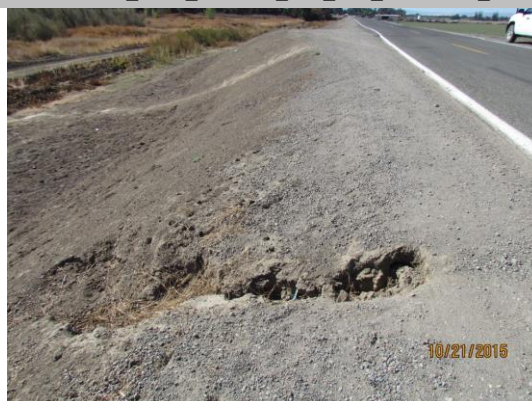
Photo 2 of 2 : FA_2018_RD1500_189_118_20180904_00054.jpg

View of the erosion on the waterward side of the levee looking upstream.
Fall 2015.

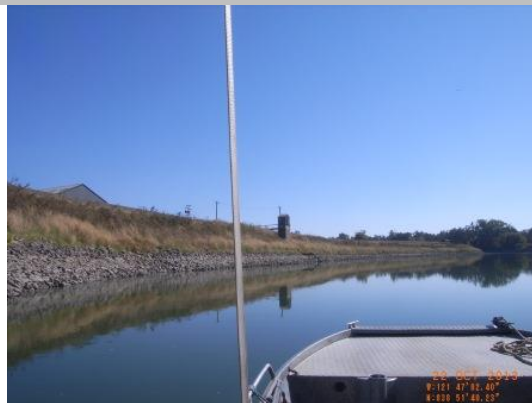
Photo 1 of 1 : FA_2018_RD1500_189_89_20181023_00239.jpg

LM Start	14.28	Rating **	A/W	Issue No.	89
LM End		Issue Type +	Ma	Location *	WS
Category	Supplemental			GPS Latitude/Longitude	
				Start	End
Item	2017 USACE Erosion Survey, DRAFT			38.861899 °	38.857239 °
				-121.784057 °	-121.783771 °
DWR ID	DWR_RD1500_01_f_2018_89				
Comment Code					
Inspector Comment					
2017 Site ID: SAC 99.0 L					
Status: Eroding					
2017 Field Notes: Rock continues to unravel.					
Site History: 1997 - Intermittent toe failure of the hand placed riprap;					
failure of toe materials.

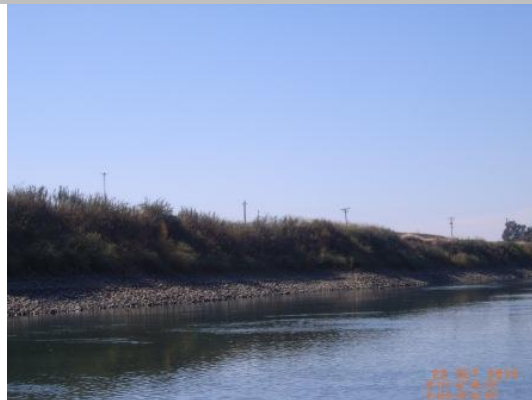
Photo 1 of 1 : FA_2018_RD1500_189_80_20181023_00017.jpg

LM Start	18.38	Rating **	A/W	Issue No.	80
LM End	19.06	Issue Type +	Ma	Location *	WS
Category	Supplemental			GPS Latitude/Longitude	
				Start	End
Item	2017 USACE Erosion Survey, DRAFT			38.901337°	38.902721°
				-121.801175°	-121.790677°
DWR ID	DWR_RD1500_01_f _ 2018_80				
Comment Code					
Inspector Comment					
2017 Site ID: SAC 104.0 L					
Status: Eroding					
2017 Field Notes: Bank slope is relatively stable.					
Site History: 1997 - Pocket failures of cobble revetment toe; scallops of rock loss along the bank; irregular bankline developing. 2001 - Small scallops in the toe of the berm. 2005 - Still multiple erosion pockets in the toe. 2006 - Two new small slumps. 2011 - Old cobble continue to fail causing minor slumping. 2012 - Portions of site appears to be stabilizing. 2016- Cobble revetment continues to fail.

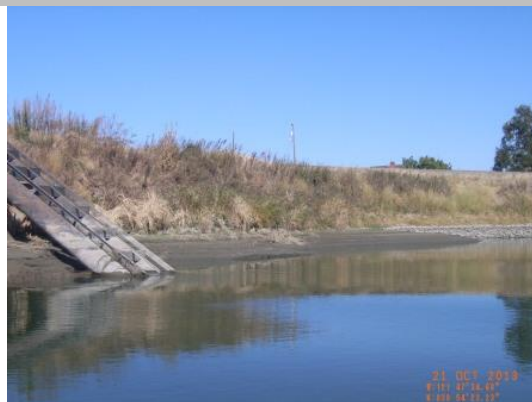
Photo 1 of 1 : FA_2018_RD1500_189_81_20181023_00043.jpg

LM Start	19.16	Rating **	A/W	Issue No.	81
LM End	19.47	Issue Type +	Ma	Location *	WS
Category	Supplemental			GPS Latitude/Longitude	
				Start	End
Item	2017 USACE Erosion Survey, DRAFT			38.904041 °	38.906697 °
				-121.790298 °	-121.792796 °
DWR ID	DWR_RD1500_01_f_2018_81				
Comment Code					
Inspector Comment					
2017 Site ID: SAC 104.5 L					
Status: Eroding					
2017 Field Notes: Site appears stable.					
Site History: 1997 - Cobbles eroded off the clay materials; not much evidence of erosion on the toe; cobble loss on the toe. 2011 - Some minor new erosion.

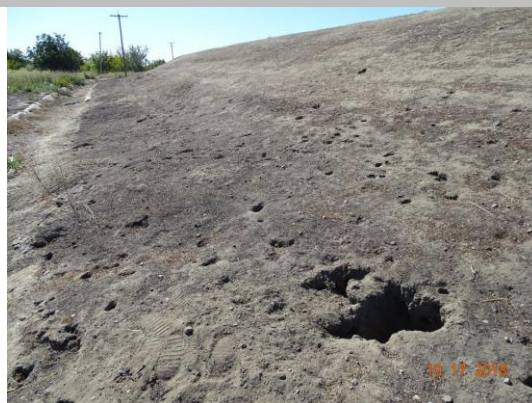
Photo 1 of 1 : FA_2018_RD1500_189_103_20181018_00232.jpg

View of rodent holes on the landside slope. Fall 2018.

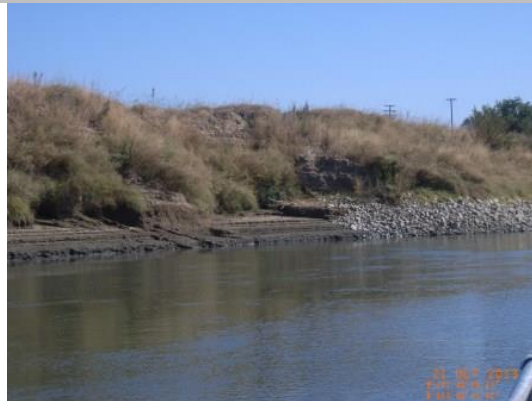
Photo 1 of 1 : FA_2018_RD1500_189_83_20181023_00048.jpg

Comment Code					
Inspector Comment					
2017 Site ID: SAC 116.5 L					
Status: Eroding					
2017 Field Notes: pipe and pump encroachment. site has been stable for a few years.					
Site History: 2003 - New sedimentation and some new small toe scallops at the upstream end; downstream end has some new erosion. 2004 - Some new erosion at the toe and upper bank and some small new rotational failures (mainly minor, except at the downstream end). 2007 - Some new slumps. 2009 - Some new scallops and site was extended upstream. 2010 - New deposition along upstream end of site, however there is also new erosion throughout the site. Site seems to be worsening, and eroding fast. Large habitat for bank swallows. 2011 - Some new minor erosion. 2012 - Minor new erosion. 2016 - Fresh erosion on lower bank.

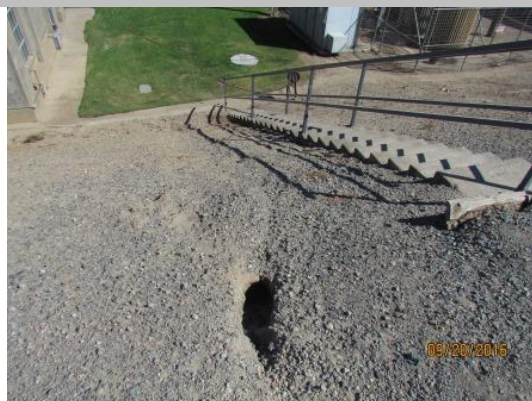
Photo 1 of 1 : FA_2018_RD1500_189_107_20180904_00044.jpg

View of rodent burrows on landside slope. Fall 2016.

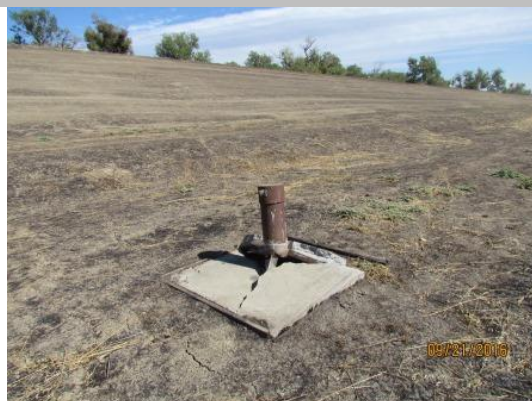
Photo 1 of 3 : FA_2018_RD1500_190_4_20180904_00001.jpg

View of underseepage relief well. Concrete pad as well as PVC pipes underneath are destroyed apparently by an attempt to pull out the head of the well. Fall 2016.

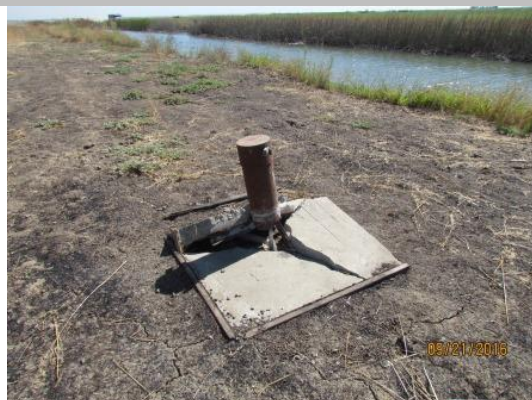
Photo 2 of 3 : FA_2018_RD1500_190_4_20180904_00002.jpg

Another view of damaged well. Fall 2016.
